**Inspection Report
of the
International Friendship Bell
for the
City of Oak Ridge
Parks and Recreation Department
Oak Ridge, Tennessee**

Date Issued – April 2014

Prepared by
TETRA TECH, INC.
1093 Commerce Park Drive
Suite 100
Oak Ridge, Tennessee 37830

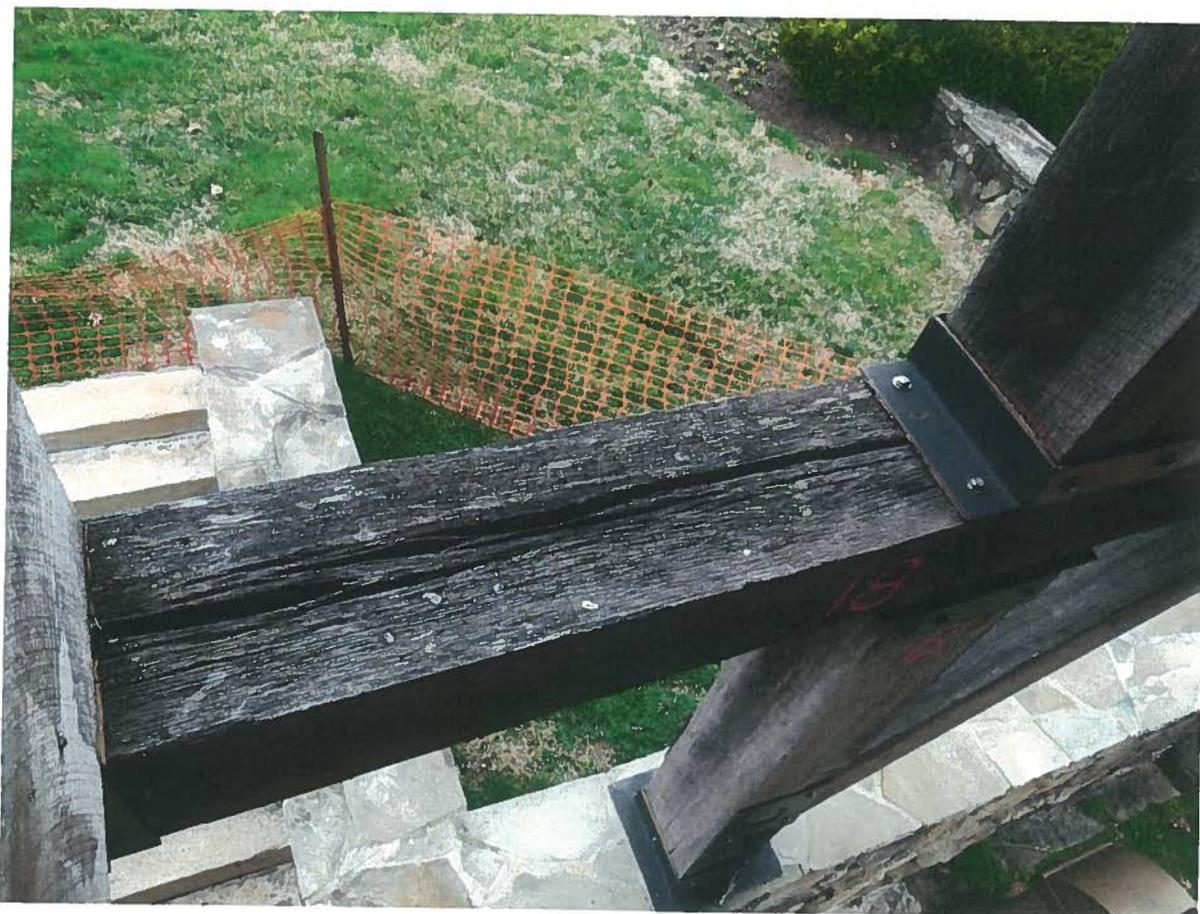
Photo 14 - Significant Checking on Member 18

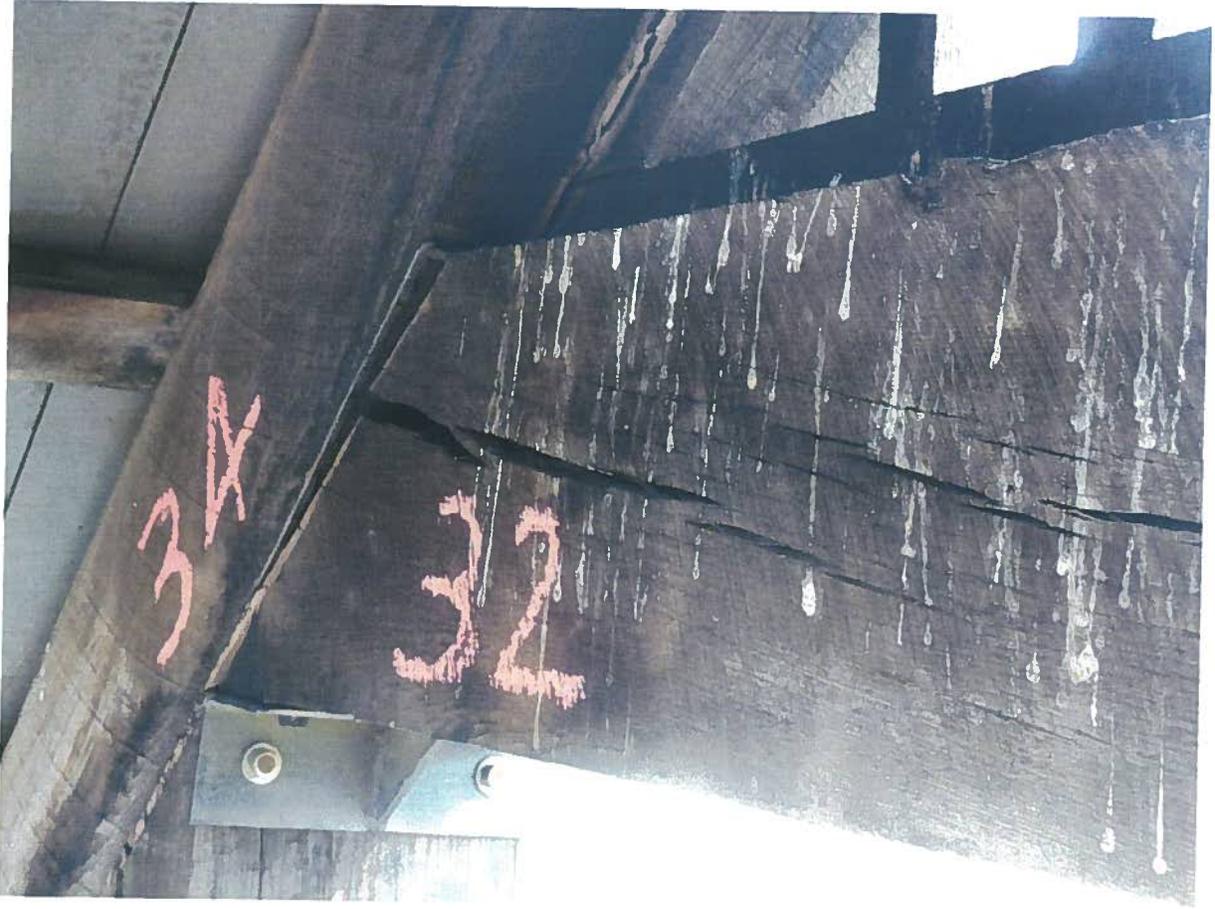
Photo 15 - Severe Checking and Sagging of Member 32

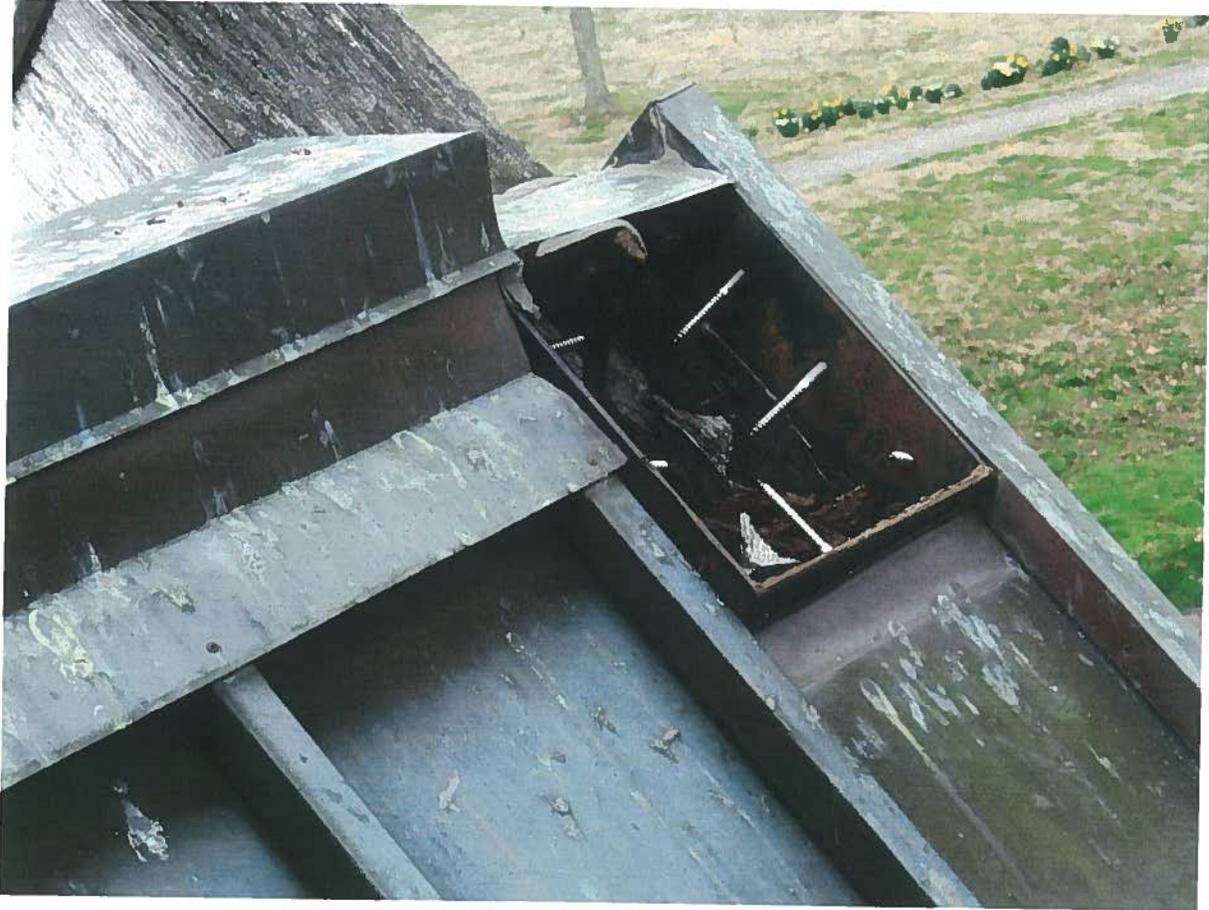
Photo 16 - Member 50 Missing at North End of Bell Structure

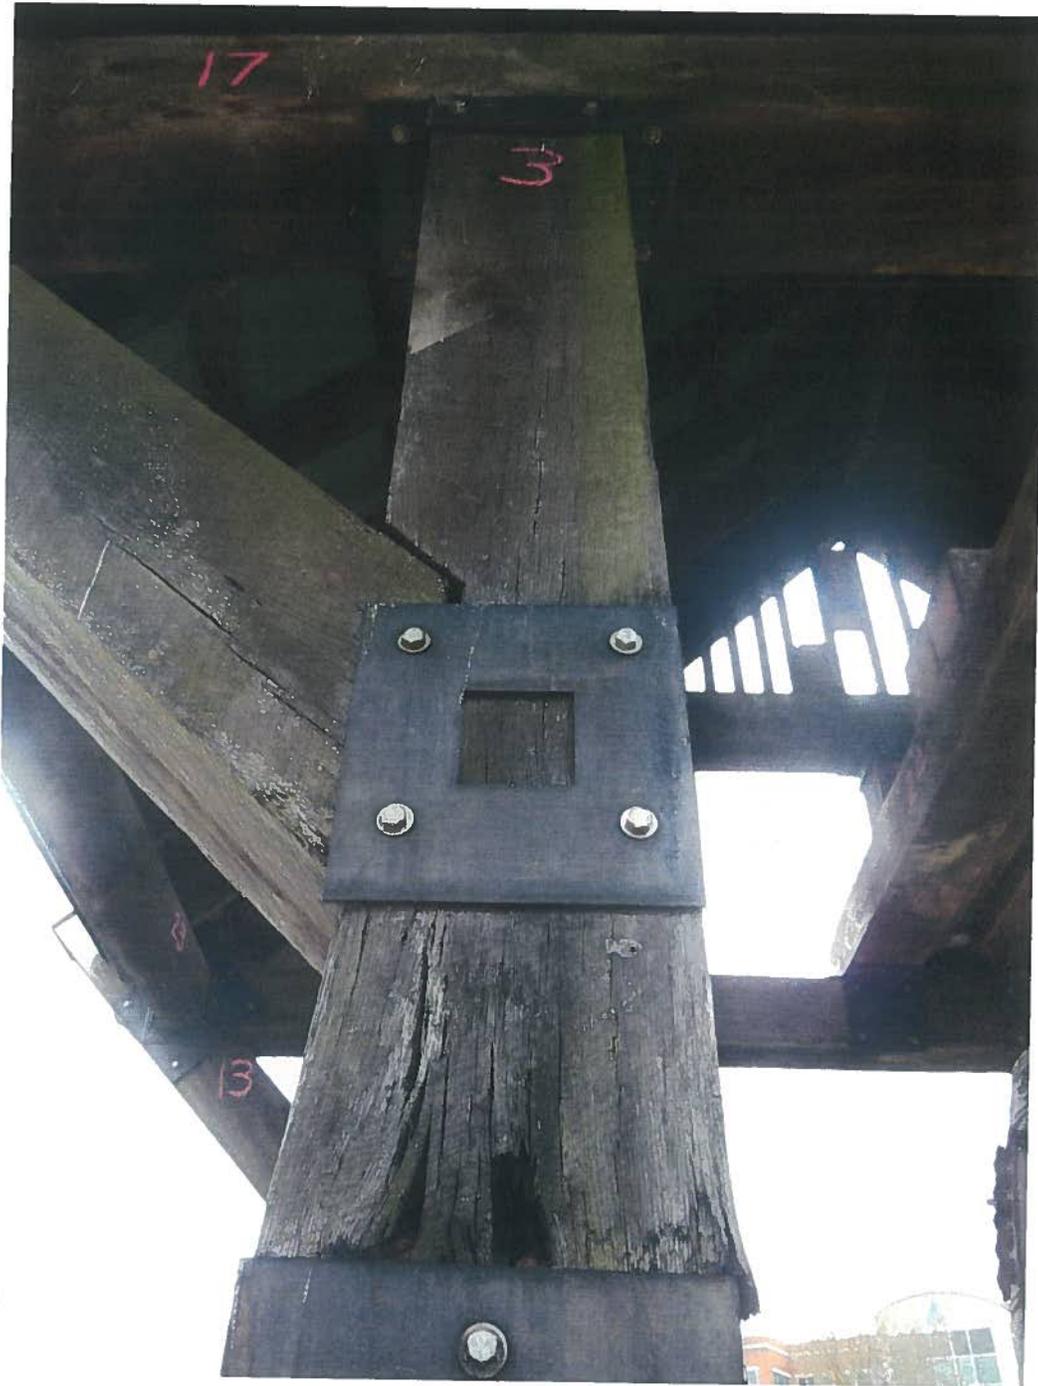
Photo 17 - Severe Splitting and Deterioration of Column 3

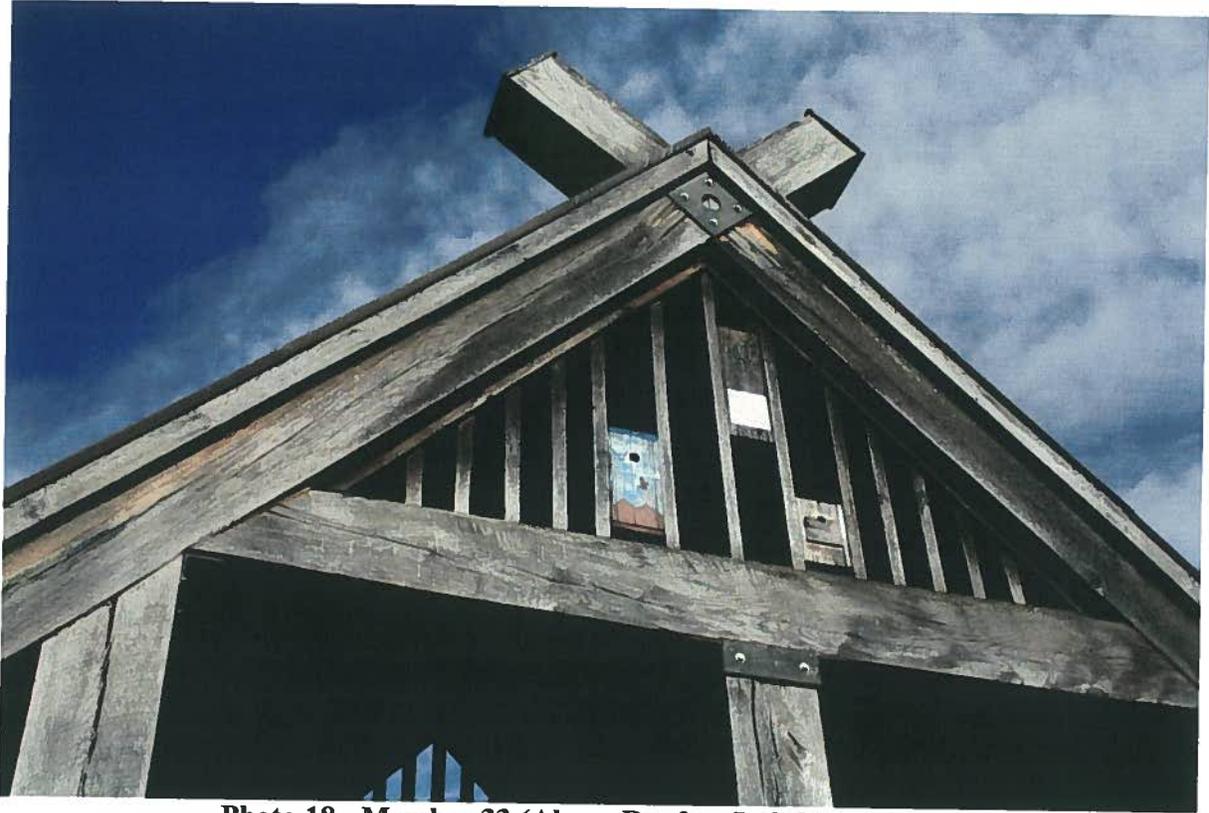
Documentation regarding the original construction of the Bell structure was not discovered from City records and archives. Most of the deterioration of the International Friendship Bell structure can be attributed directly to unprotected exposure to weather. The most significant deterioration occurred in members that were not protected by the roof. The open gable ends also permitted inclement weather to wear down the exposed trim and structural wood members. Additional deterioration of primary structural members resulted from a gutter/trough design for the roof that involved placement of welded structural steel members into hollowed out cross-sections of the heavy timber framing members. At one of the members protruding above the roof surface, a large hole was discovered with a squirrels nest inside the member.

Photo 18 - Member 33 (Above Roof on Left-Not Labelled)

Squirrels Nest inside Member 33 (Member 48 Above Roof on Right – Not Labelled)

- D. For all wood members located above the roof line, consider replacing these members with false members of a different material type that give the appearance of wood. The false members could utilize the bolted connections of the existing roof structure.

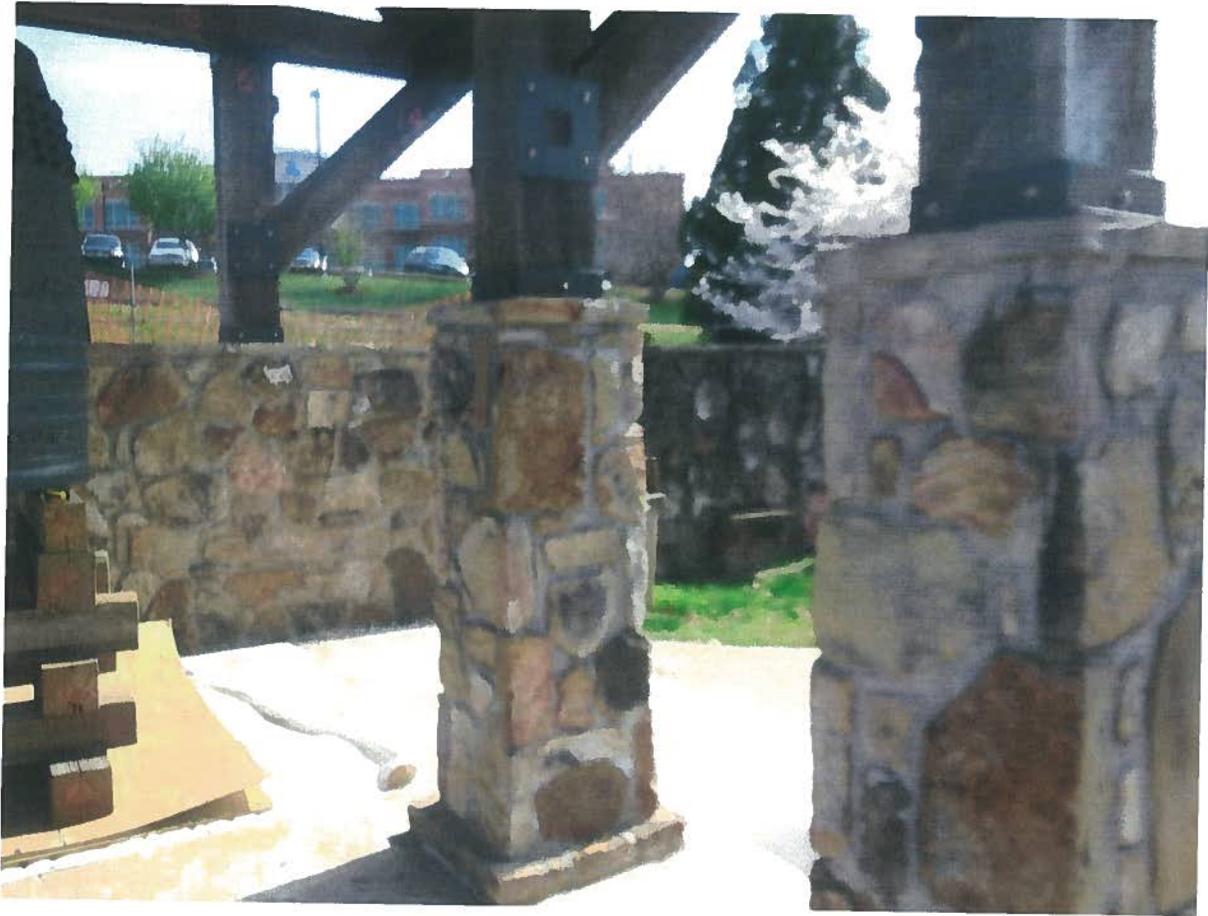
Photo 19 - Typical Pedestal (Columns 2 & 4 shown)

Cribbing under the Bell in the Background

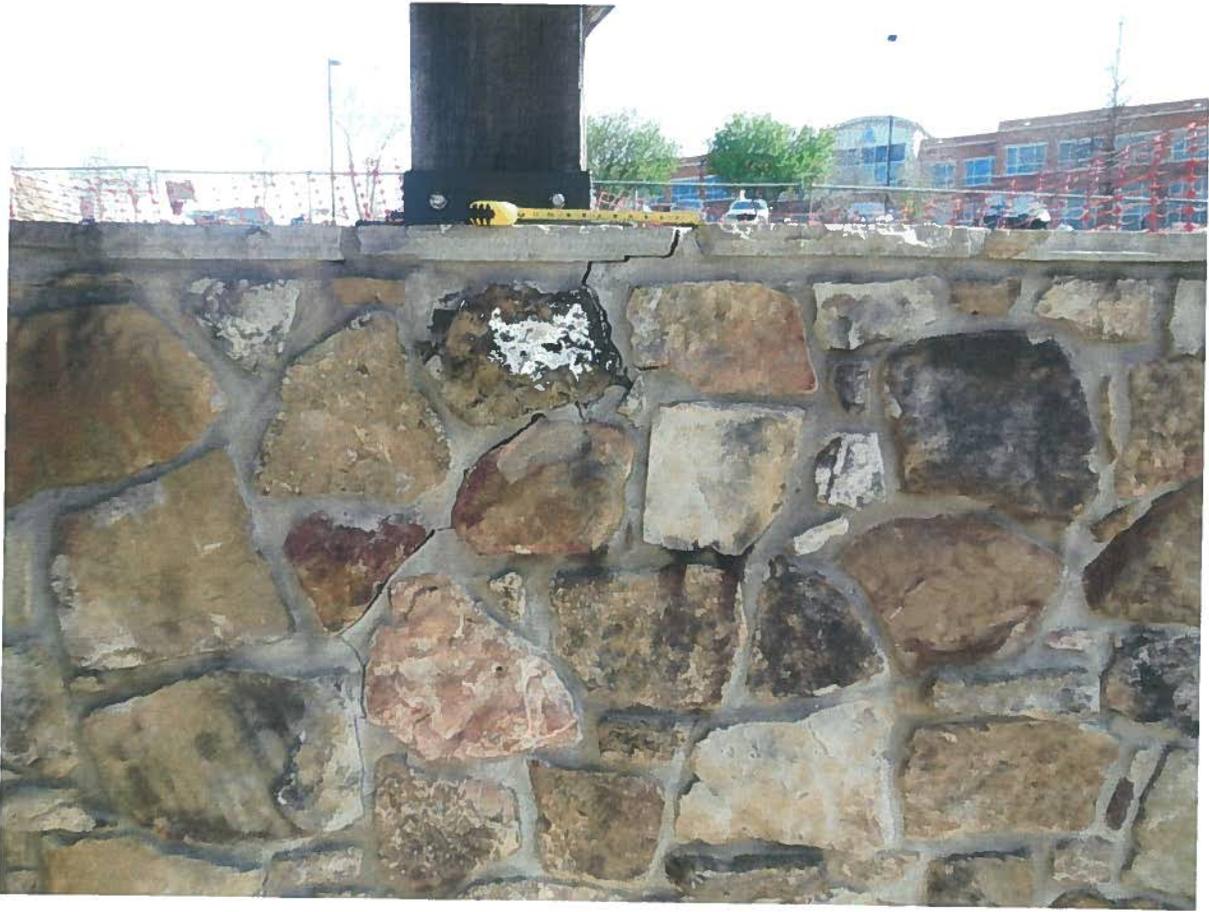
The stone/masonry retaining wall at the south end of the Bell structure has vertical and diagonal cracks adjacent to Column 6 supporting the 8,250 lb. bronze bell and one fourth of the high bay roof structure. There are also diagonal cracks along the west wing wall. These cracks indicate load and settlement issues of the retaining wall structure.

Photo 20 - Meandering Crack in Stone/Masonry Wall below Column 6

- F. Replace at least a portion of the stone/masonry wall with masonry pilasters or short reinforced concrete columns under the two south wood columns. Depending on the existing foundation /slab, small spread footings under these columns may be required. As a minimum, annual or biannual inspections of the existing stone/masonry wall are recommended to monitor additional movement.

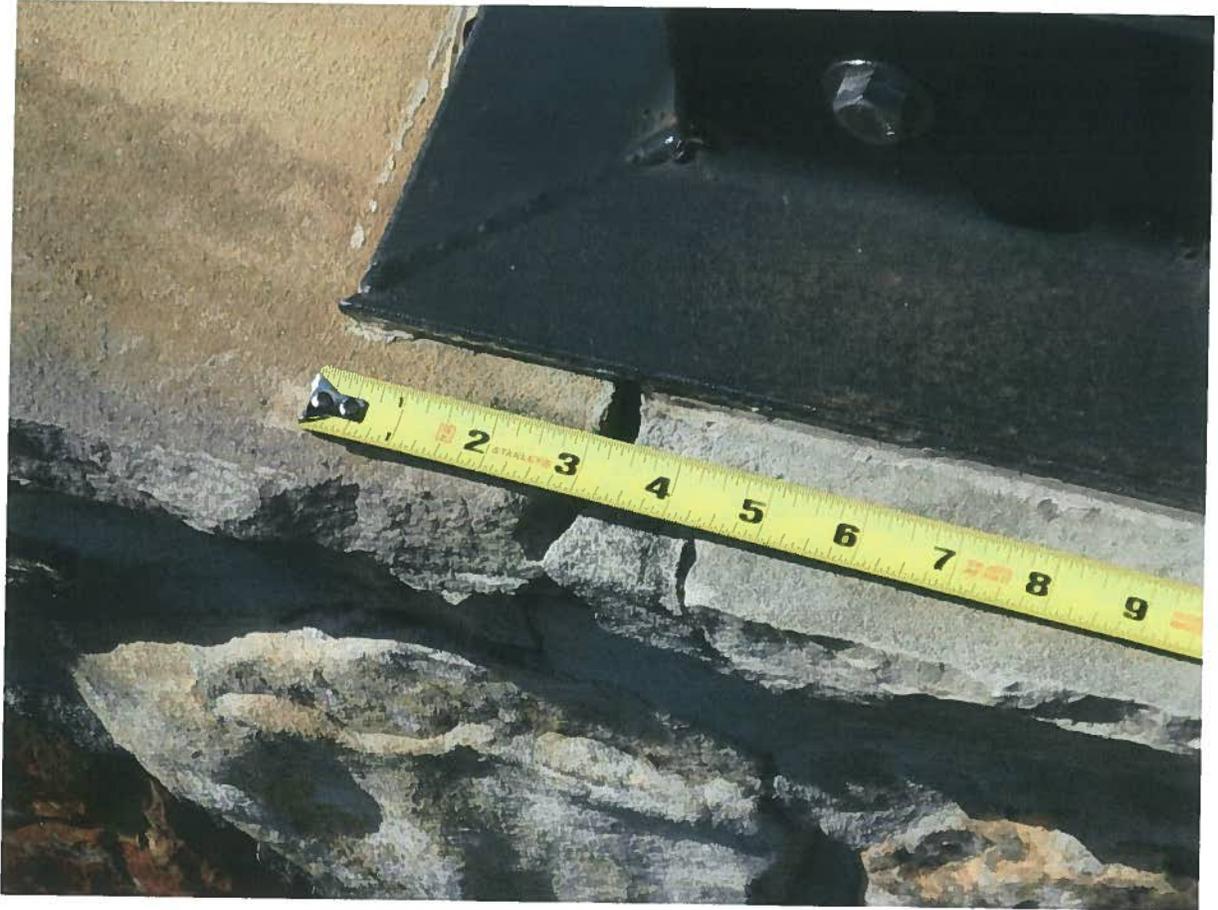
Photo 21 - Crack at Top of Stone/Masonry Wall below Column 6

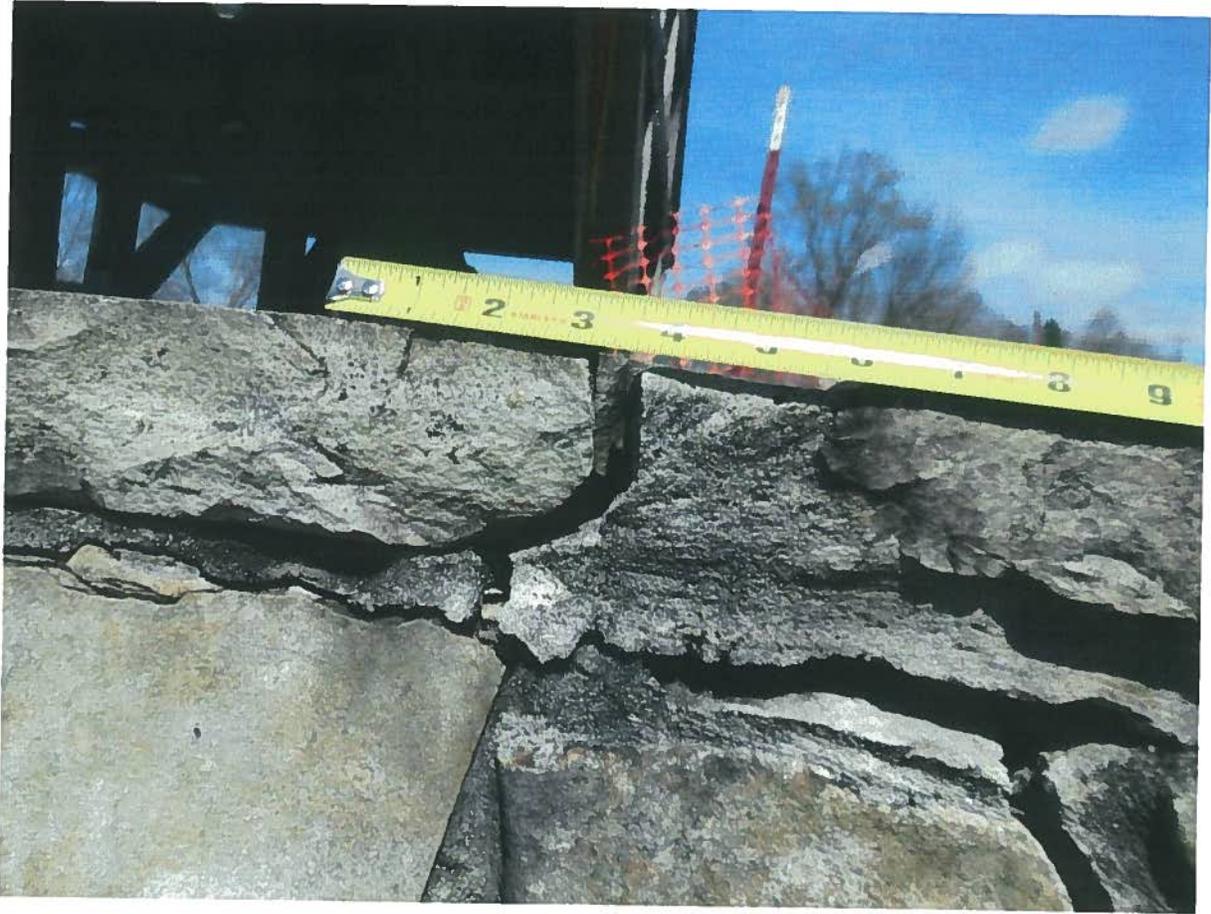
Photo 22 - Crack at Top of West Wing Wall

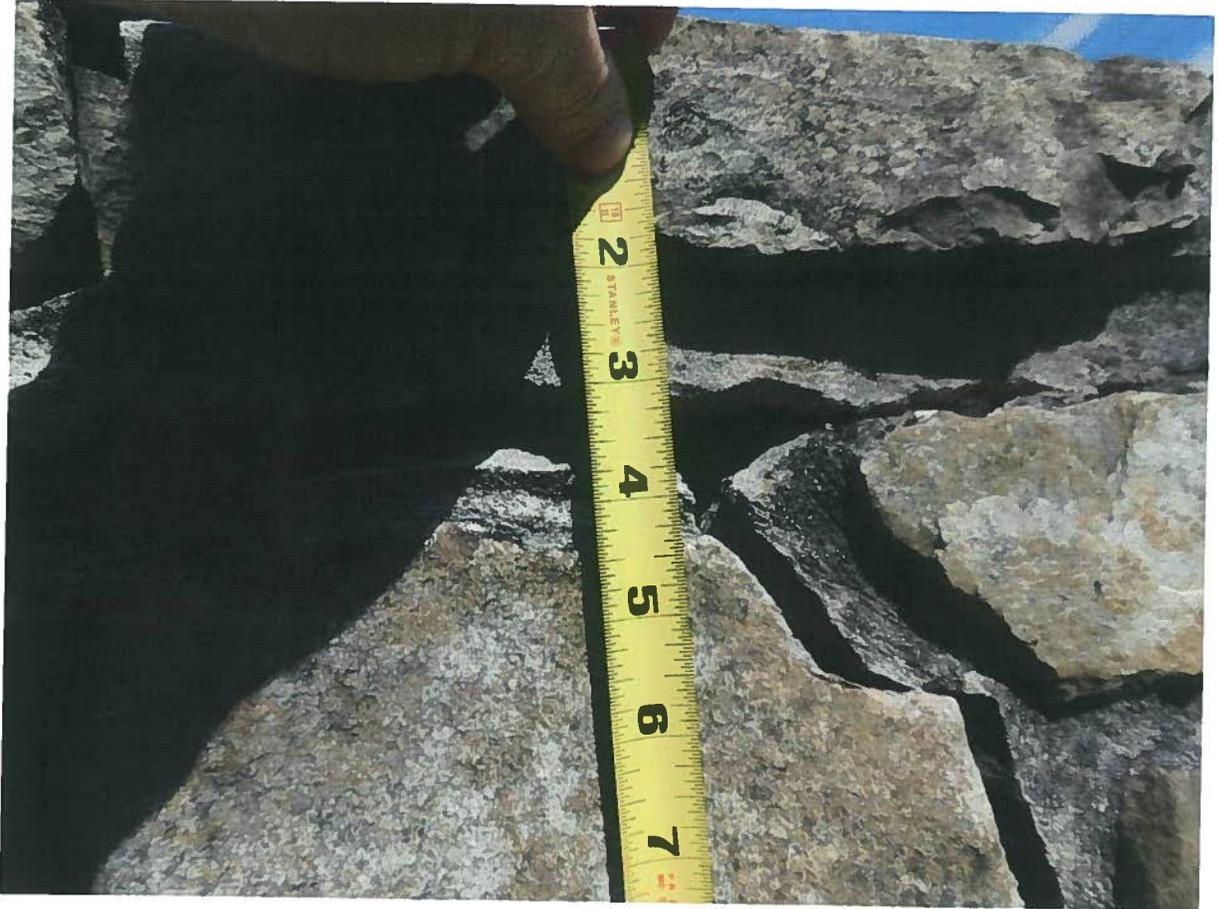
Photo 23 - Crack in West Wing Wall - Below the Cap

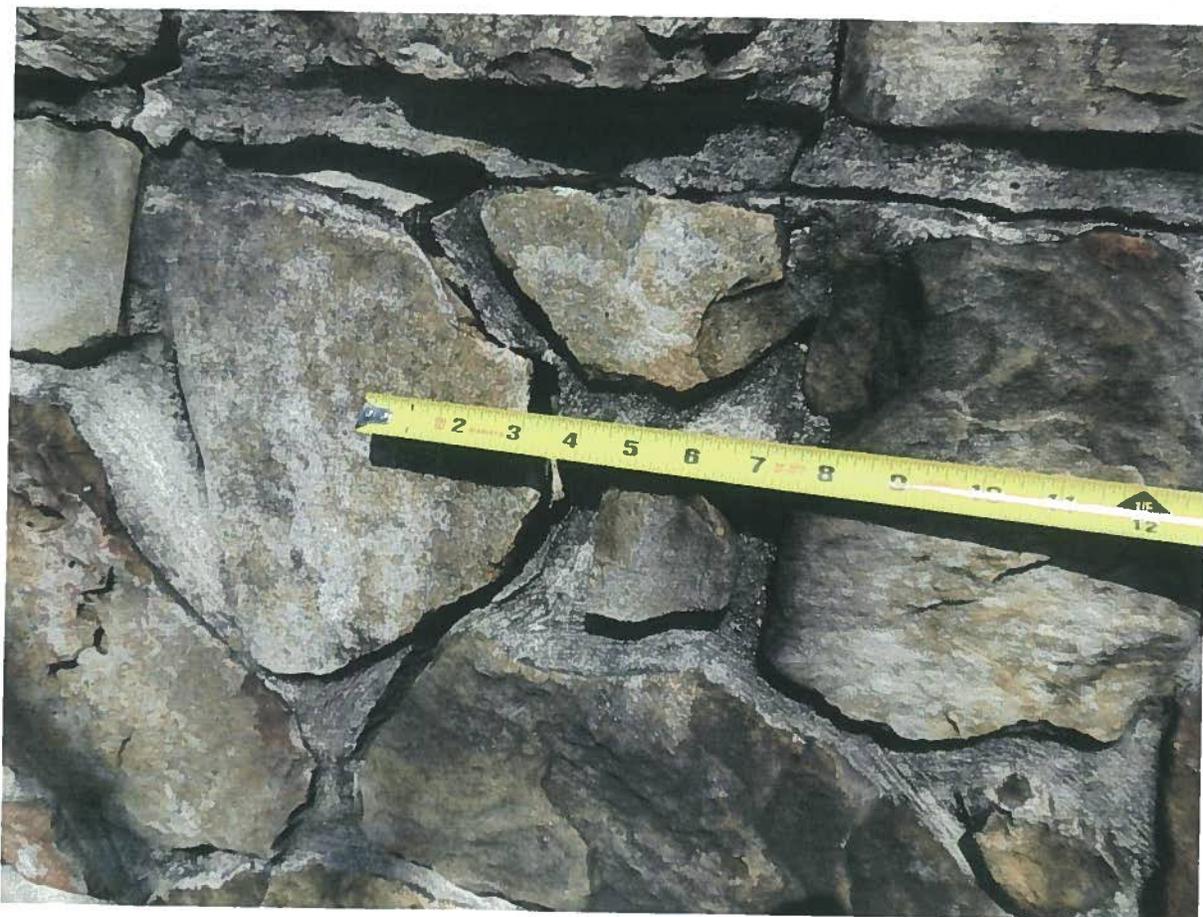
Photo 24 - Crack in West Wing Wall - Near the Top

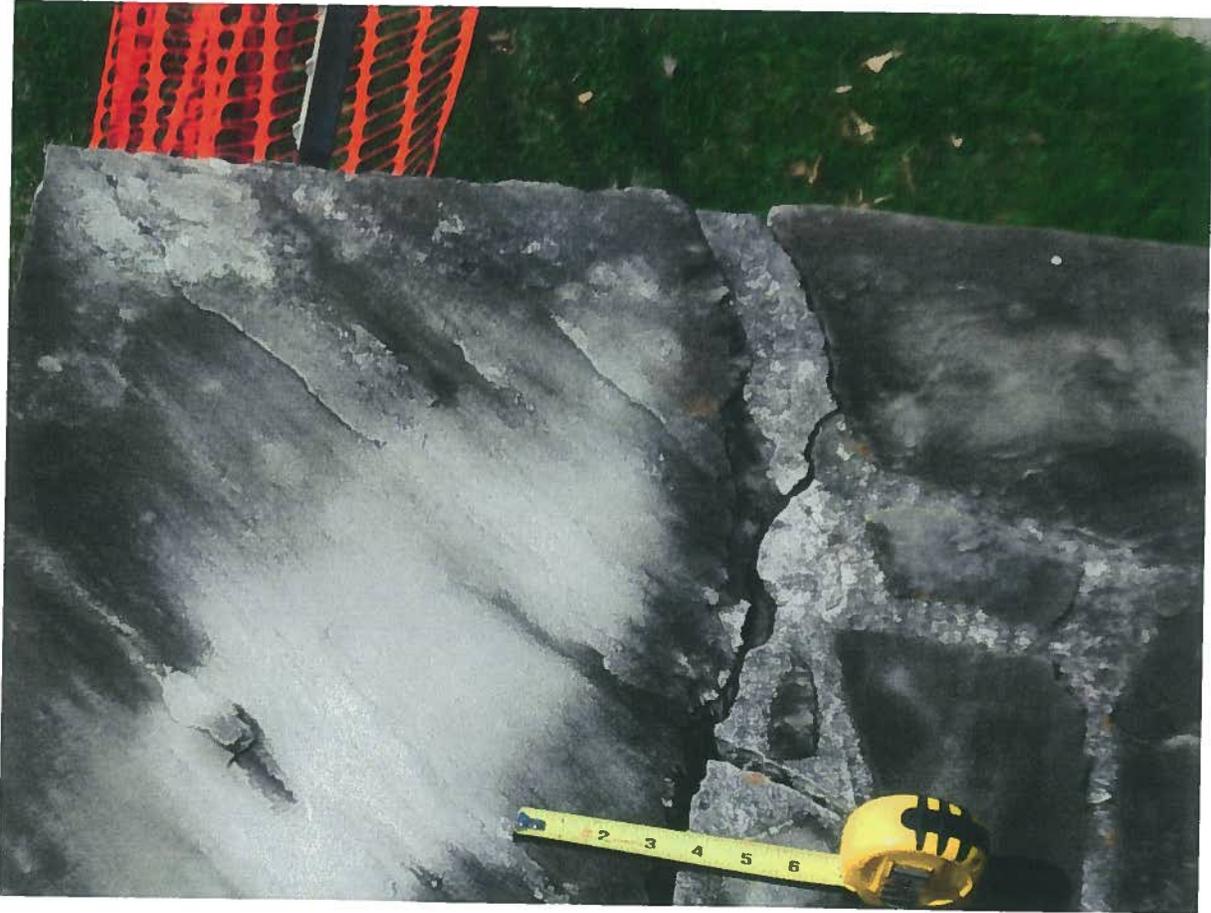
Photo 25 - Crack at Top of West Wing Wall - North West Corner
