**Inspection Report
of the
International Friendship Bell
for the
City of Oak Ridge
Parks and Recreation Department
Oak Ridge, Tennessee**

Date Issued – April 2014

Prepared by
TETRA TECH, INC.
1093 Commerce Park Drive
Suite 100
Oak Ridge, Tennessee 37830

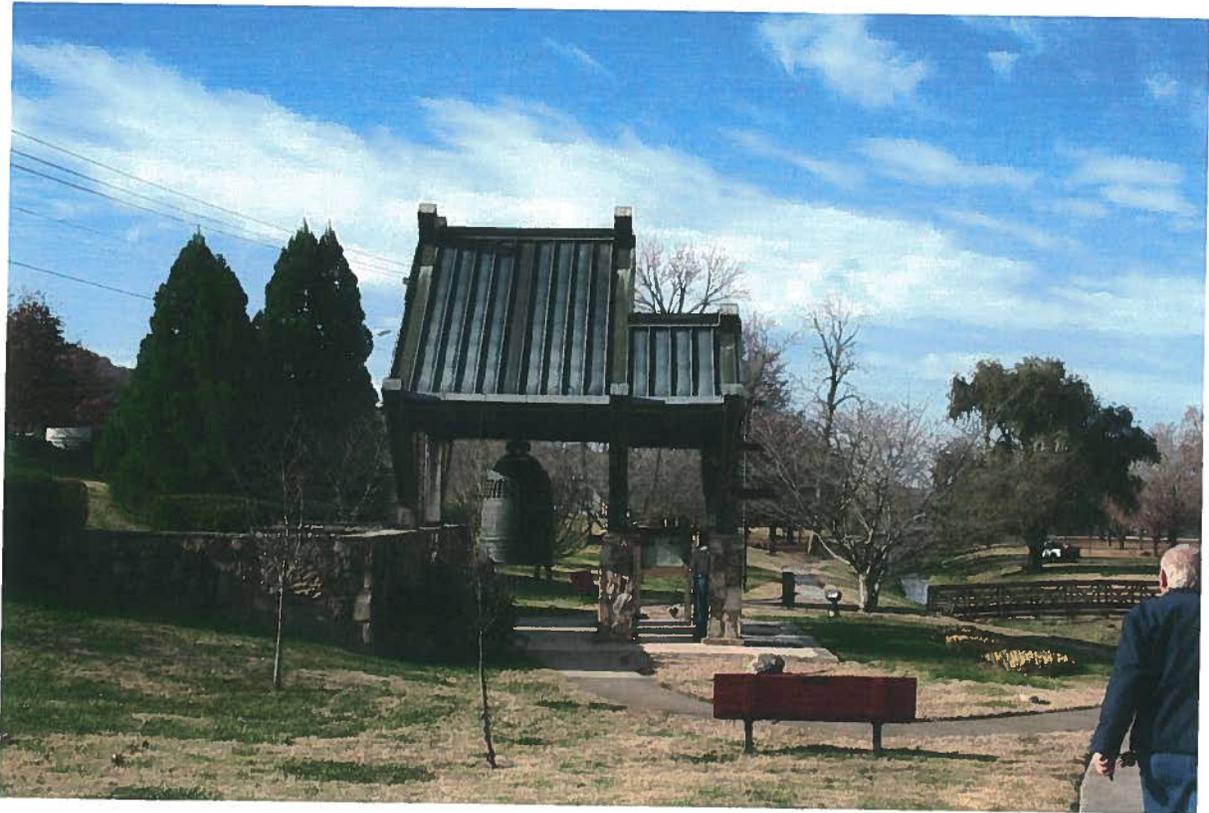
Photo 1 - International Friendship Bell Structure (Looking East)

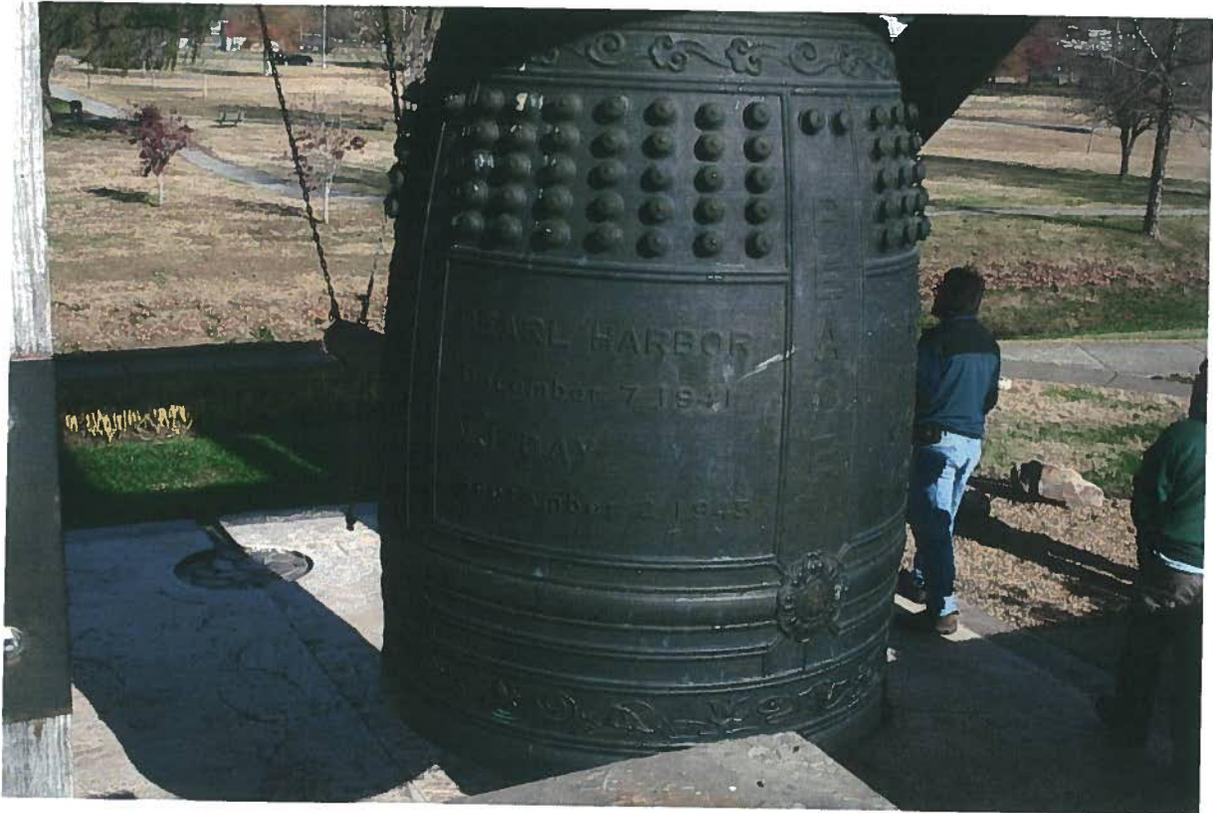
Photo 2 - International Friendship Bell (Approx. 8,250 lbs.)

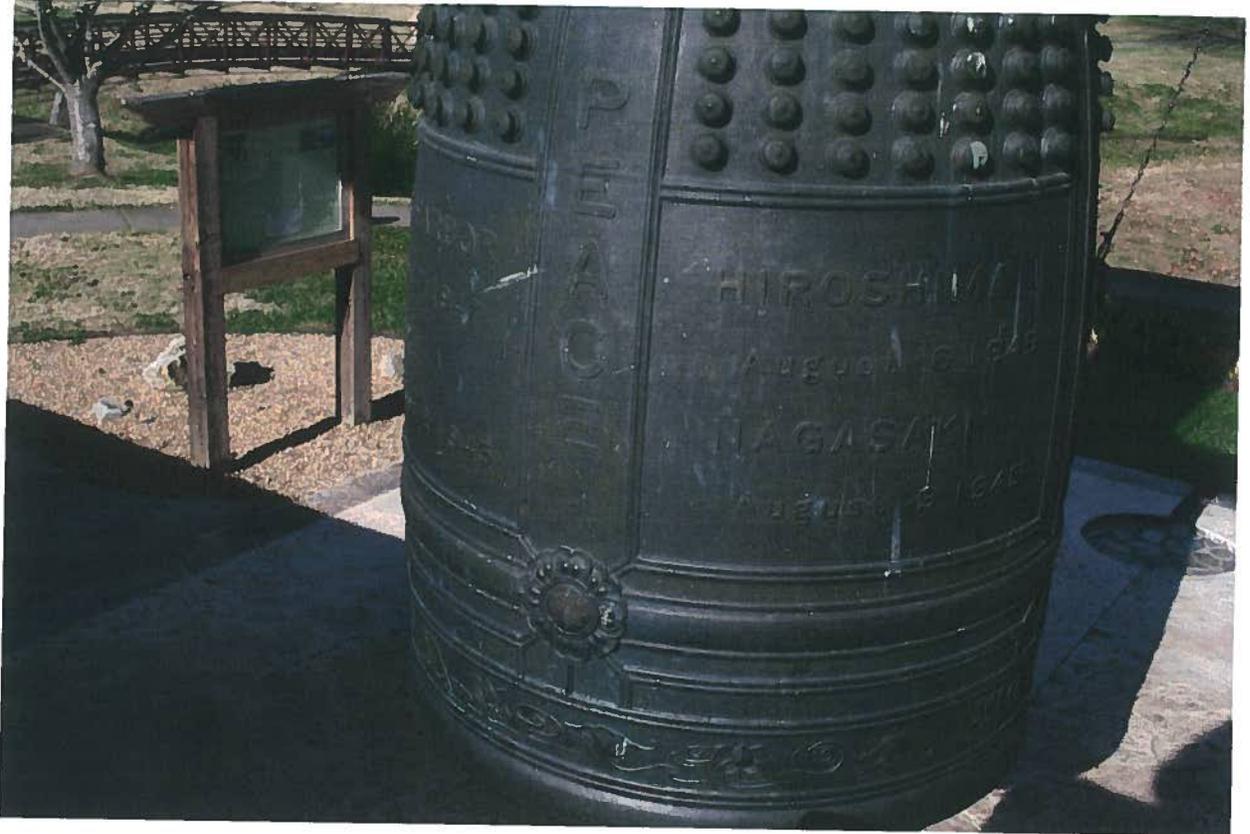
Photo 3 - International Friendship Bell (Looking North West)

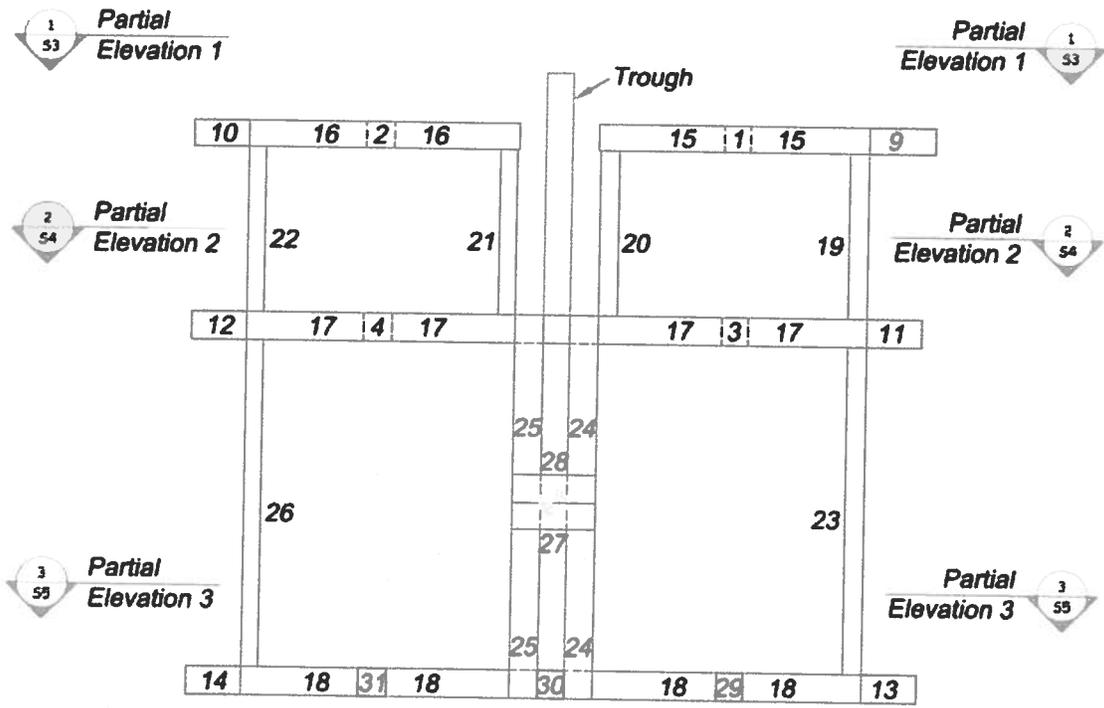
Drawing 2 - Plan View at Elevation 12 Feet

*Columns 1, 2, 3, and 4 terminate at the bottom of Beams 15, 16, and 17.
Beams 19, 20, 21, 22, 23, and 26 are nominally 8" square.
Unless noted otherwise, all other members are nominally 12" square.*

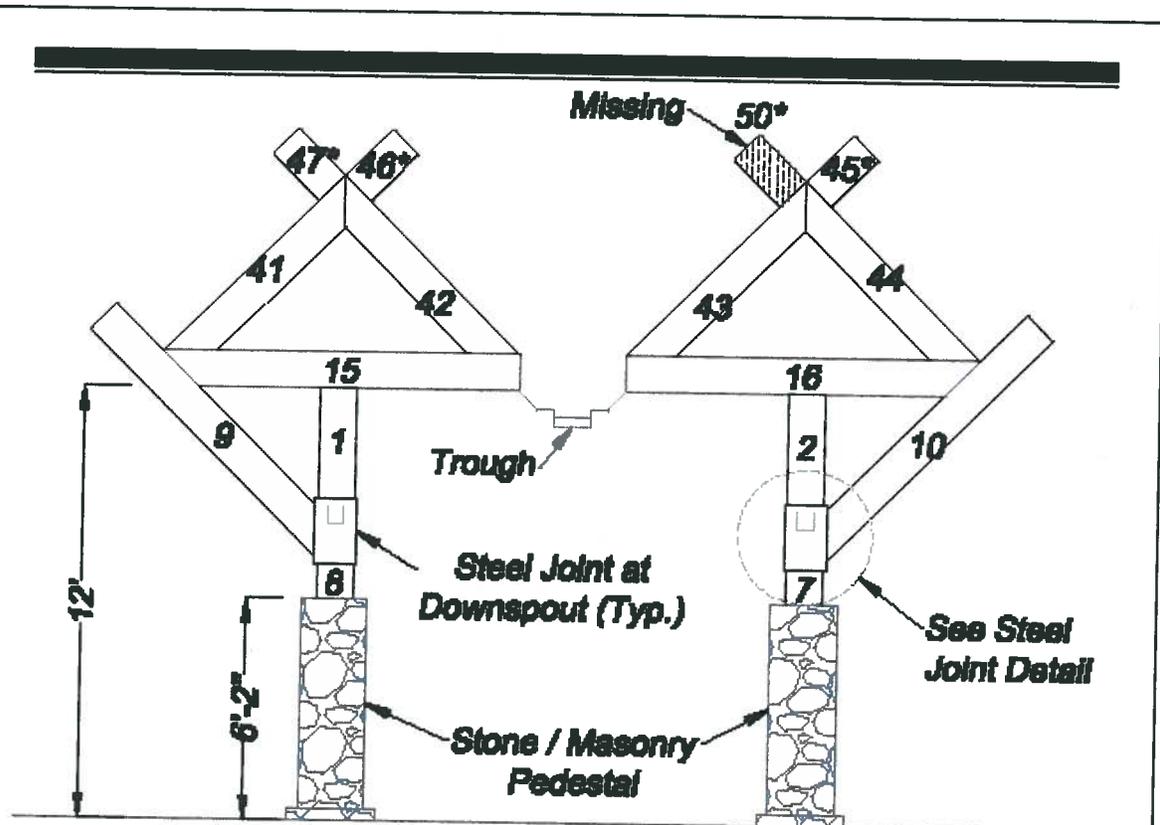
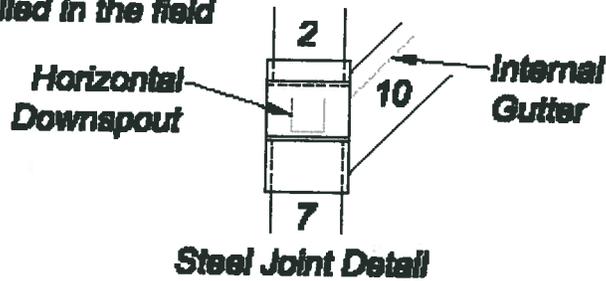
Drawing 3 - Partial Elevation 1

* - Not labelled in the field

Unless noted otherwise, all members are nominally 12" square.

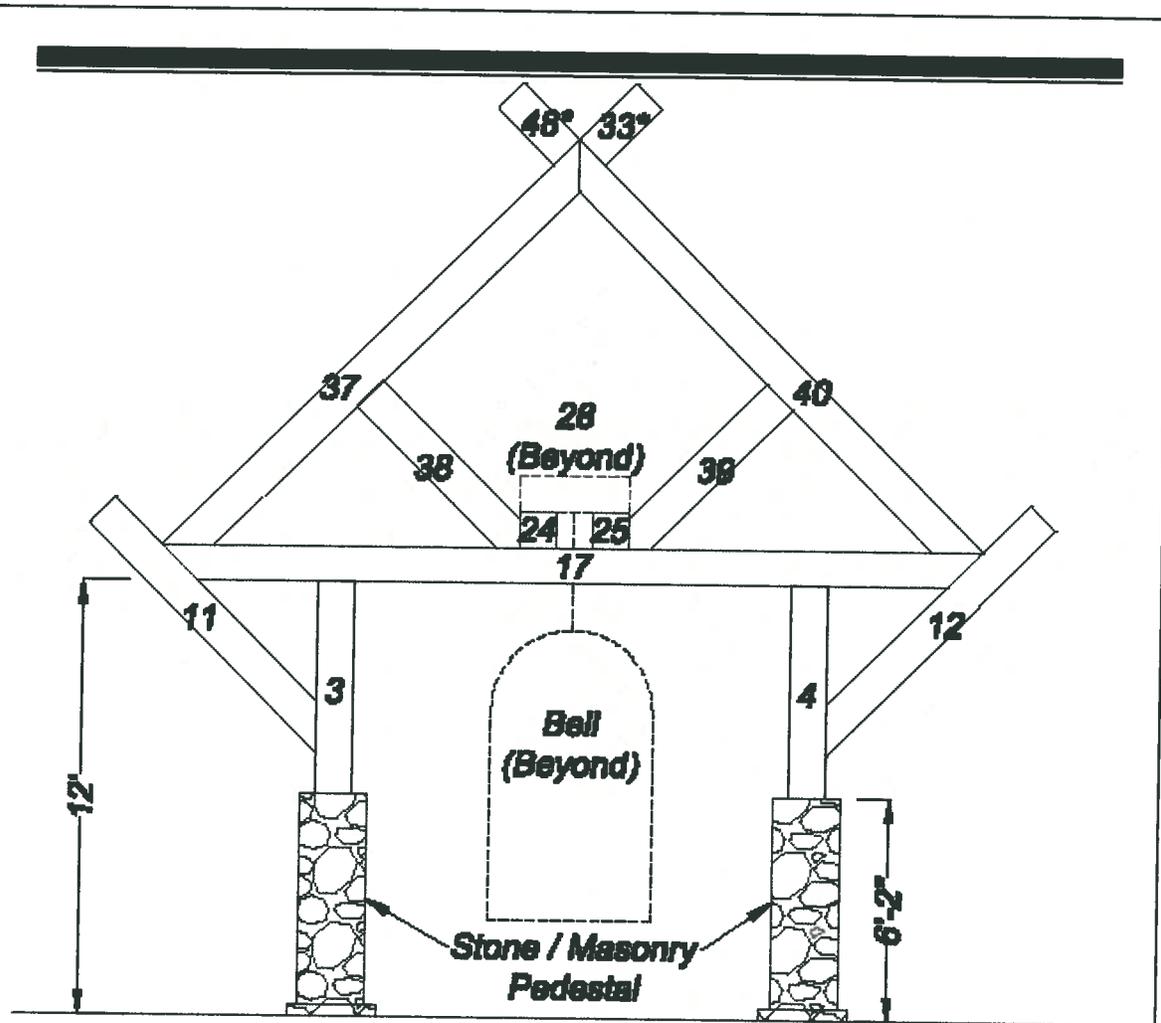
Drawing 4 - Partial Elevation 2

** - Not labelled in the field*

**Unless noted otherwise, all members
are nominally 12" square.**
